**S.O. 3922.**—In pursuance of section 27 of the Mines Act, 1952 (35 of 1952) the Central Government hereby publishes the report submitted to it under sub-section (4) of section 24 of the said Act by the Court of Inquiry appointed under that section by the notification of the Government of India in the Ministry of Labour and Employment No. M.1-2/1/65, dated the 14th June 1965 to hold an inquiry into the causes of and circumstances attending the accident which occurred in the early hours of 28th May, 1965 in the Dhori Colliery, Bermo P.O., Hazaribagh Dist., Bihar.

**REPORT OF ENQUIRY INTO THE DHORI COLLIERY DISASTER, 1965.**

## REPORT OF ENQUIRY INTO THE DHORI COLLIERY DISASTER OF 1965

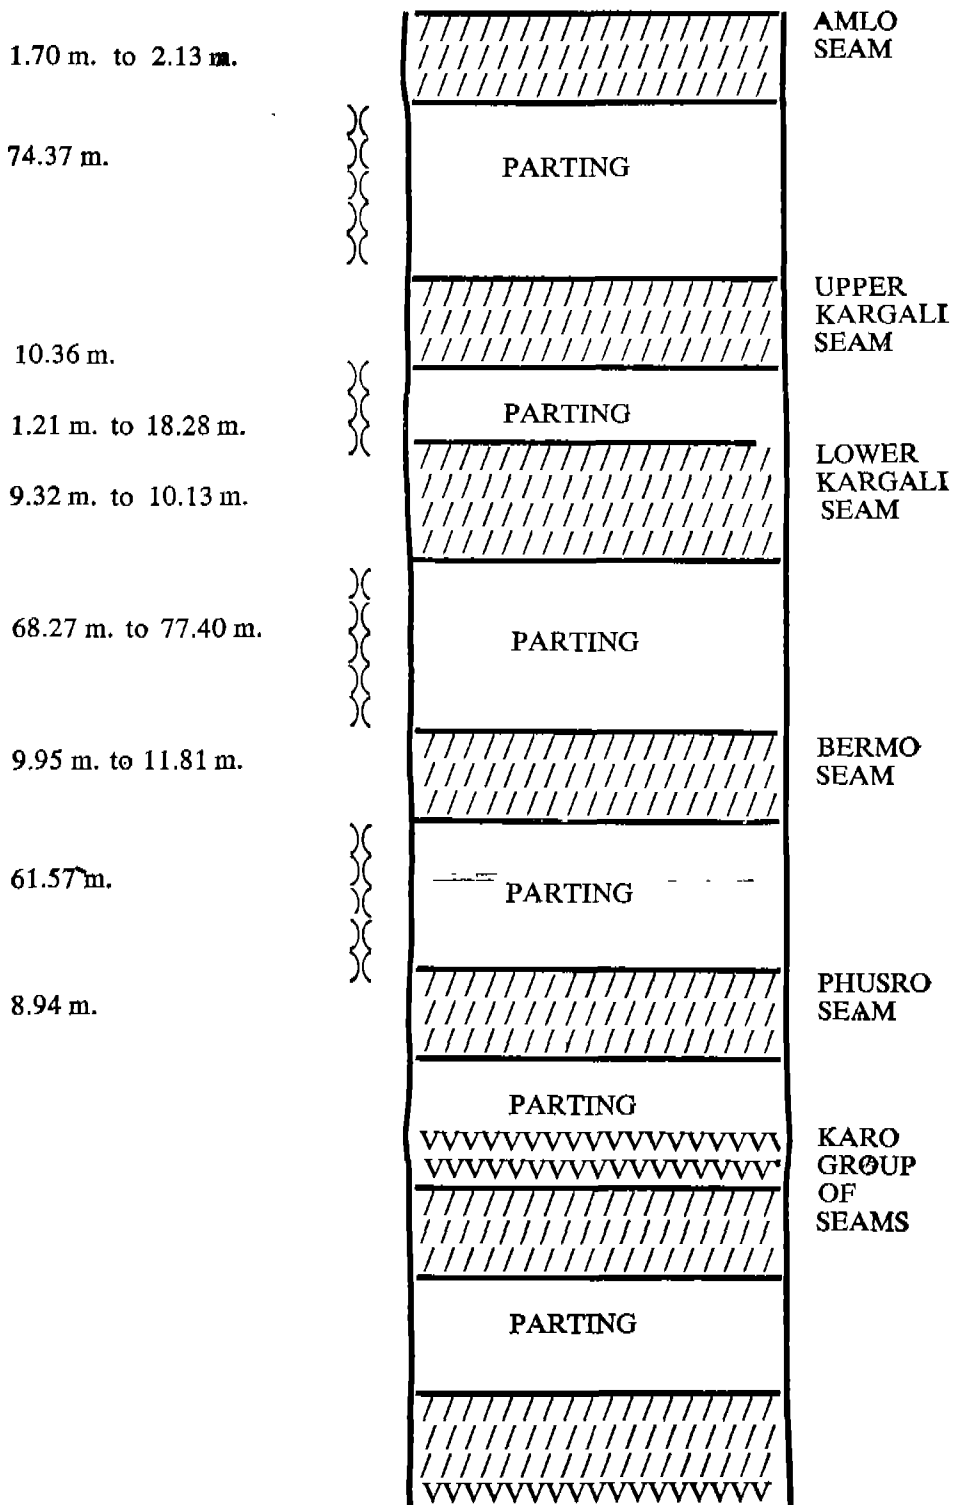
18. The Dhori colliery consists of a number of seams such as Amlo seam, Kargali seam in two sections (upper Kargali and lower Kargali), Bermo seam, the Karo group of seams including Phusro seam. The following section shows the thickness of the seams and the parting between them.
